Comments for CPUC Utility Pole Census and Competitive Access Order Instituting Investigation, 17-06-027

Catherine Sandoval
Associate Professor
Santa Clara University School of Law
CPUC Public Participation Hearing
May 21, 2018, San Jose, California

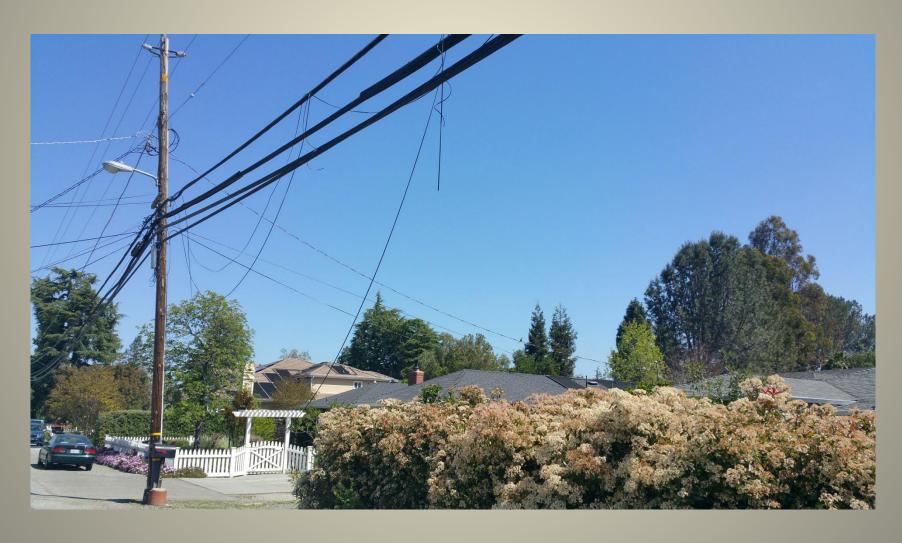
SAFETY, RESILIENCY, AND MAINTENANCE ISSUES, Dangling wires, Campbell, CA (Issue repaired, 2016), photo by Catherine Sandoval

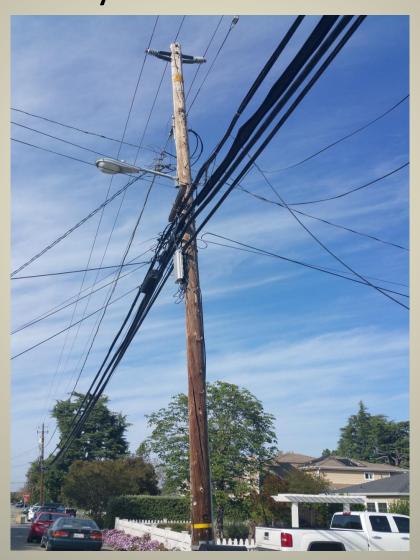
Joint Use Pole with Dangling Wire, Campbell, CA Pole Replaced with PEG pole, Nov. 2016, photo by Catherine Sandoval

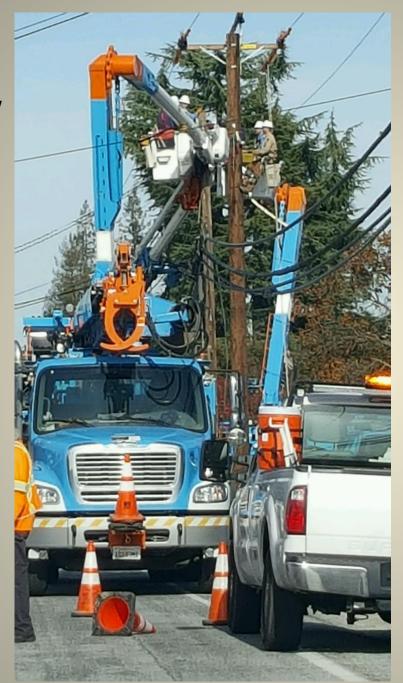
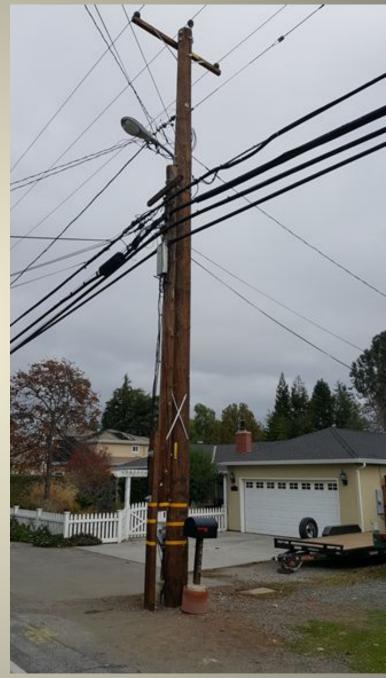
"Buddy Pole," created by PG&E when new utility pole planted to replace leaning pole, Nov. 2016, Campbell CA.

Buddy Pole still in place with Telecom lines attached, May 2018

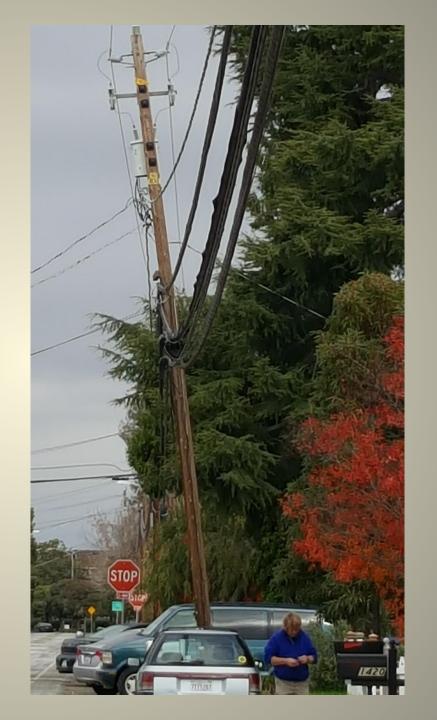
Leaning Pole,
Campbell, CA
Photo taken in 2016
by Catherine Sandoval

Pole still leaning, May 2018

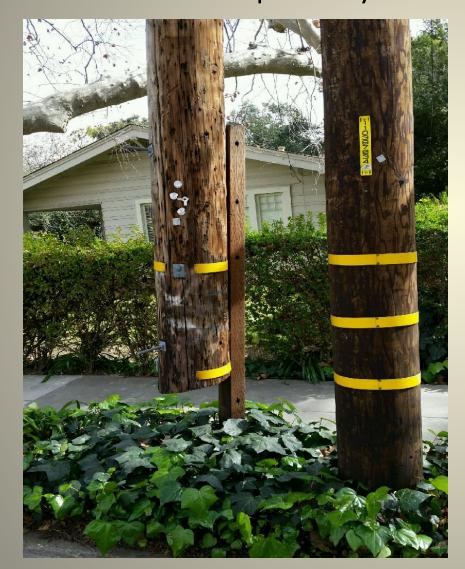
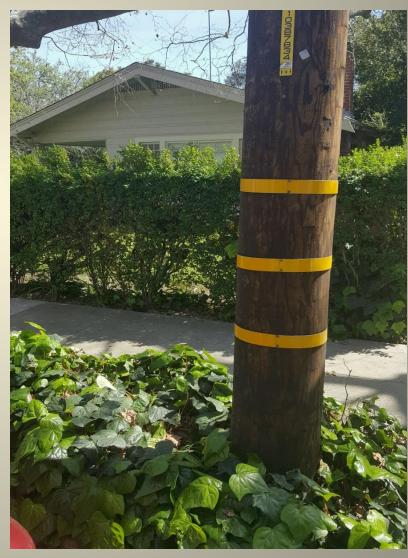
Pole with Bottom cut off, Propped by Wooden Post, San Jose, California, Willow Glen Neighborhood, February 2018, photo by Christopher Klapperich, February 2018. Buddy pole removed by March 2018, photo by Catherine Sandoval.

Top of braced Buddy Poles with Bottom cut off, Held up by Wooden Post, San Jose, California, Willow Glen Neighborhood, February 2018. Photo by Christopher Klapperich

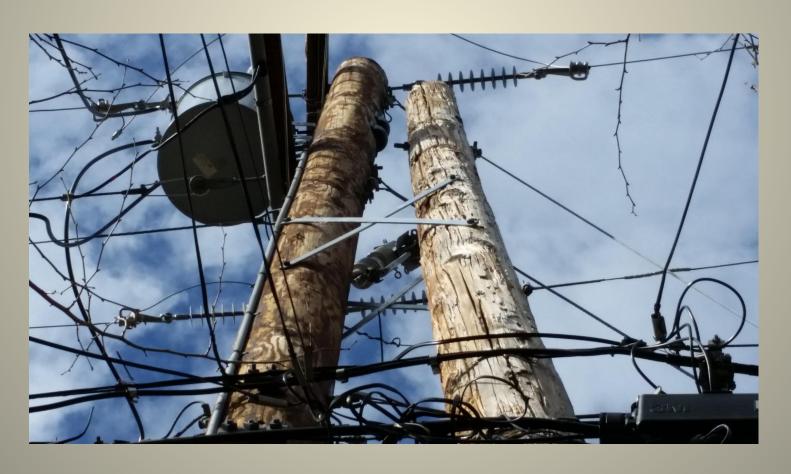
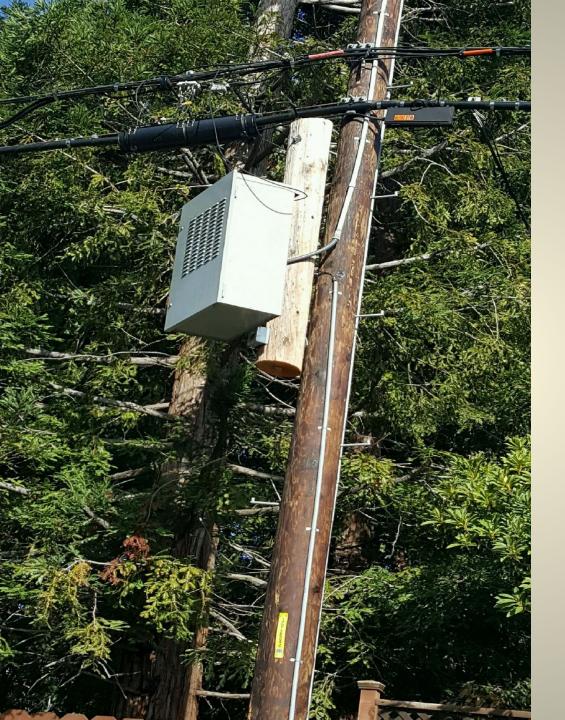
Climbing Space to Electric Facilities Obstructed

Buddy Pole removed by March 2018, climbing space still obstructed

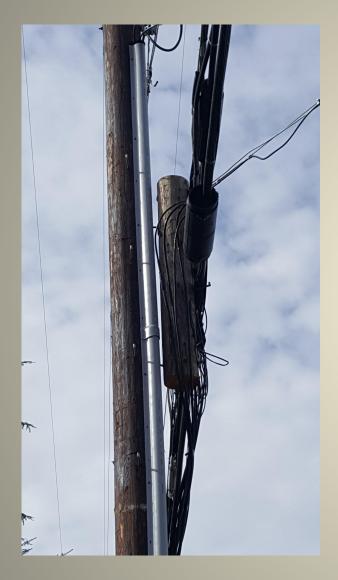
Internet Power
Equipment on "Peg"
at angle on Pole,
Los Gatos, CA

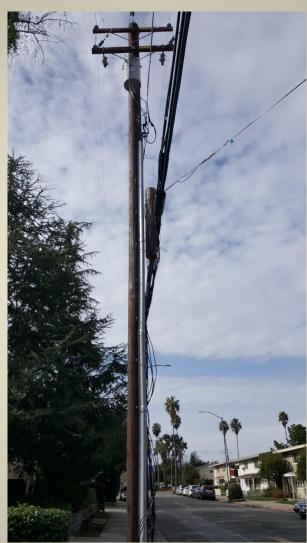
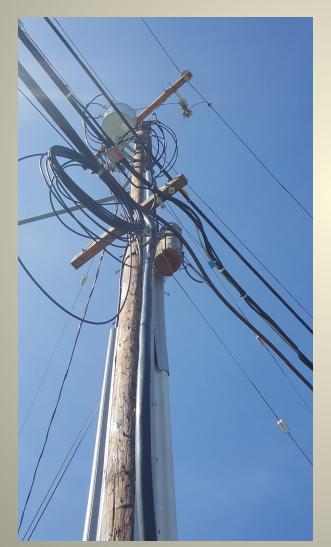
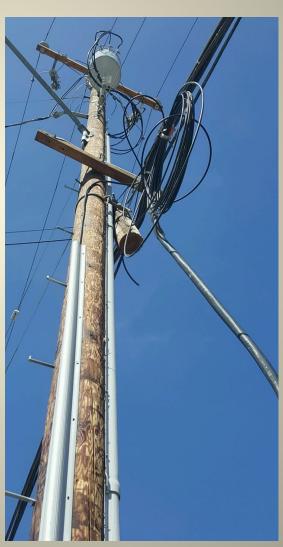
Peg on Pole with telecom wires attached, Campbell, CA

Photo by Catherine Sandoval January 2018 Peg of Old Utility Pole Tied to Utility Pole by Rope, Large Telecom Wire Coil, Electric Climbing Space Obstructed, San Jose, CA, Willow Glen Neighborhood, March 2018, Photos by Catherine Sandoval

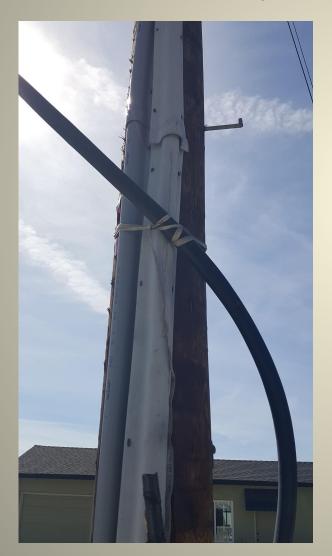
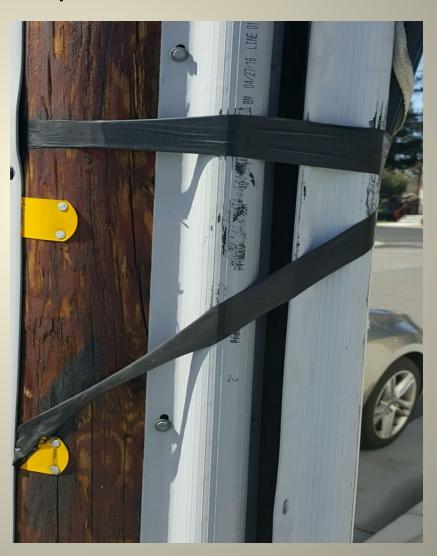
Telecom Remote Facilities linked to Conduit Taped to Joint Use Electric/Communication Utility Pole,
San Jose, CA, Willow Glen Neighborhood
March 2018, Photos by Catherine Sandoval

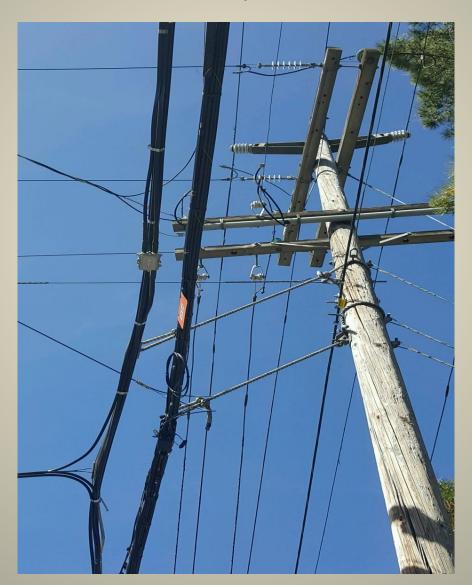
SAFETY, RESILIENCY, AND COMPETITION Issues, Telecom wires tied by Rope to Pole, Electric Climbing Space Obstructed, San Jose, CA, Willow Glen Neighborhood, March 2018, Photos by Catherine Sandoval

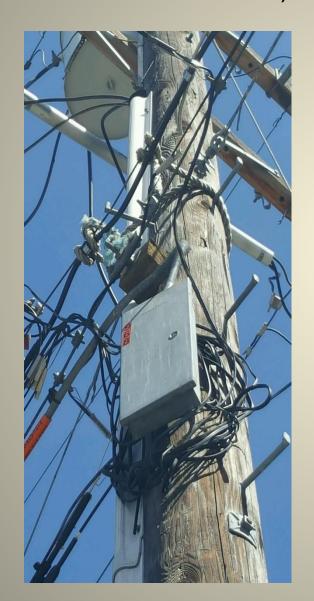
SAFETY, RESILIENCY, AND COMPETITION Issues, Telecom wires tied by Rope to Pole, Electric Climbing Space Obstructed, San Jose, CA, Willow Glen Neighborhood, March 2018, Photos by Catherine Sandoval

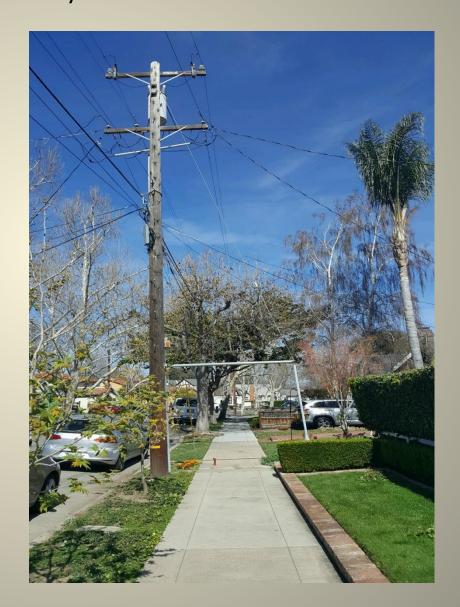
Large Telecom facility attached to pole McLaughlin Ave, San Jose, CA, Bonita-24th Neighborhood Photo by Catherine Sandoval May 2018

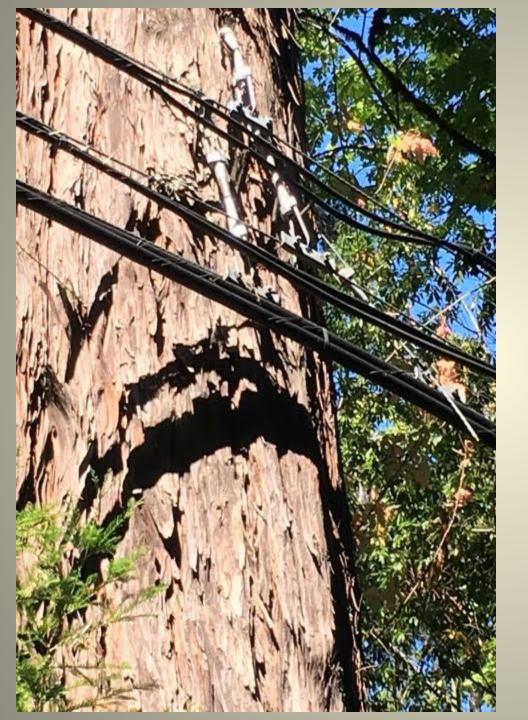
Telecom Lines Attached to Tree, Sonoma CA

Photo by Michael Nicholls, 2018 Telecom Lines Attached to Trees, Photo on the Left, Telecom line threaded through dead tree, Sonoma CA, 2016, CPUC Ordered lines be moved to a proper utility pole.

Photo on right, Telecom lines tied to tree Felton, CA, 2016.

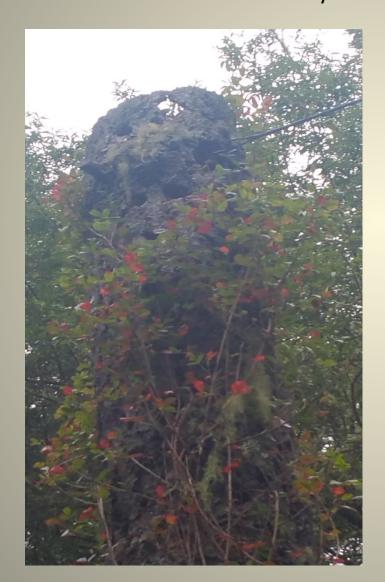
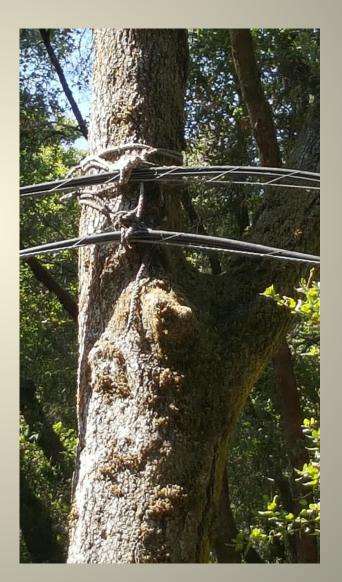
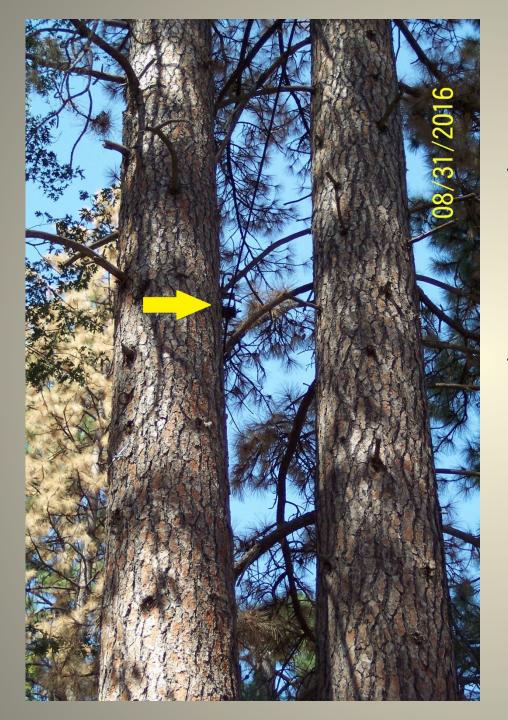
Telephone line attached to tree, Drew Meadow, CA, Next to Firefighter's Camp for 2013 Rim Fire

Tree dead or dying from bark beetle infestation in the background on the left.

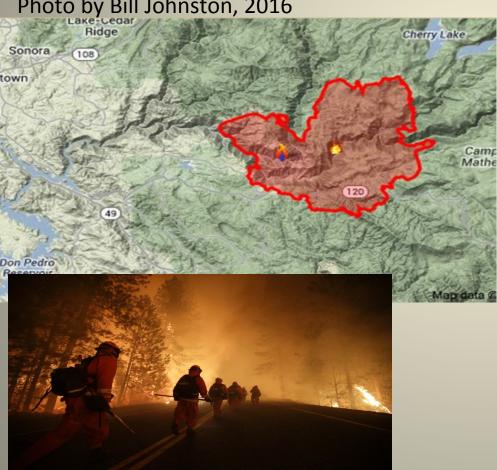
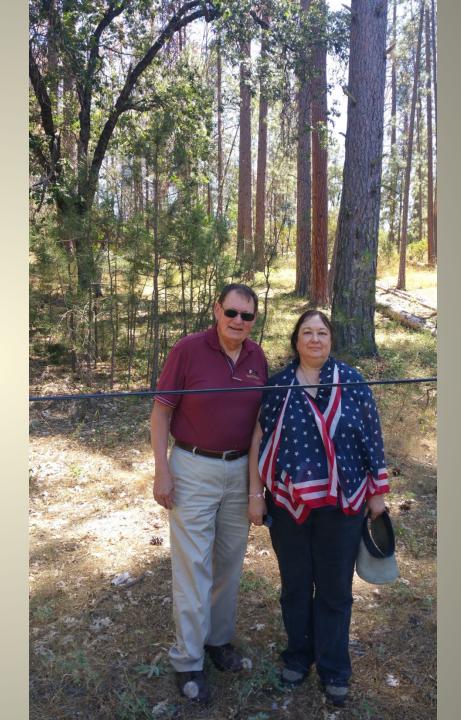
Photo by Bill Johnston, 2016

CPUC Commissioner Sandoval (term served Jan. 2011-Jan. 2017) with Tuolumne County Supervisor Randy Hanvelt, standing next to low Telecom Line strung to dead and dying trees, abutting the site of the fire-fighters' campsite at Drew Meadows for the 2013 Rim Fire Trees dead or dying from bark beetle infestation in the background.
